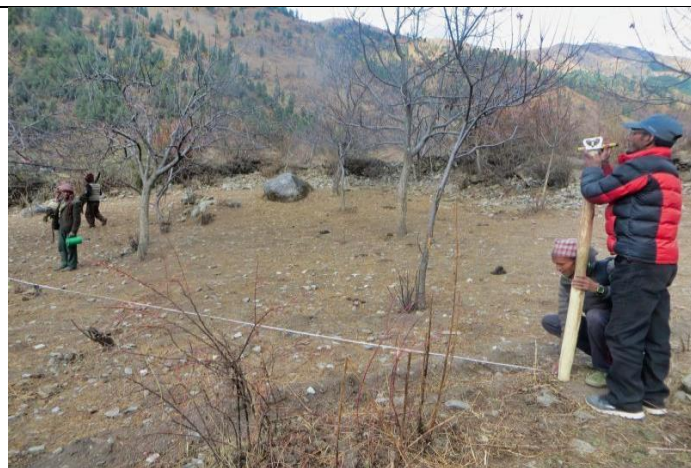
**Pic. 2:** Plans as well as precise material and equipment lists are drawn up for the laying of the high-density polyethylene (HDP) water pipes. The total length of the water pipes (from the source to Pere and the distribution to the 15 taps in the village) is ~ 3 km

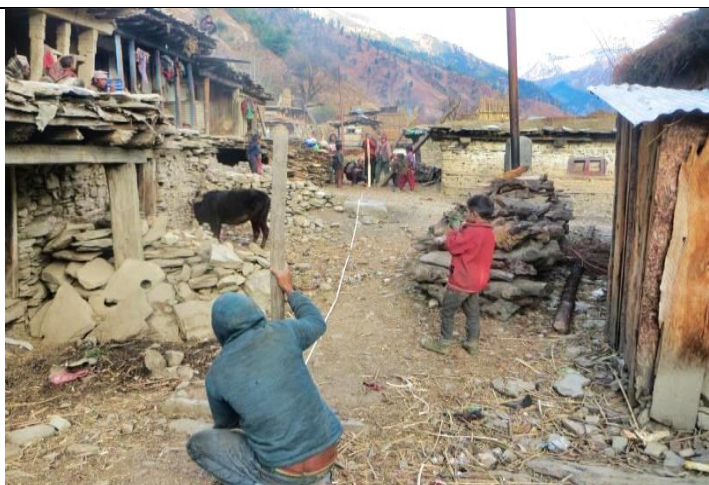
**Pic. 3:** The water pipes in the village are laid in such a way that all residents can get their daily water for family and animals from one of the 15 tap stands within 1-2 minutes walking distance

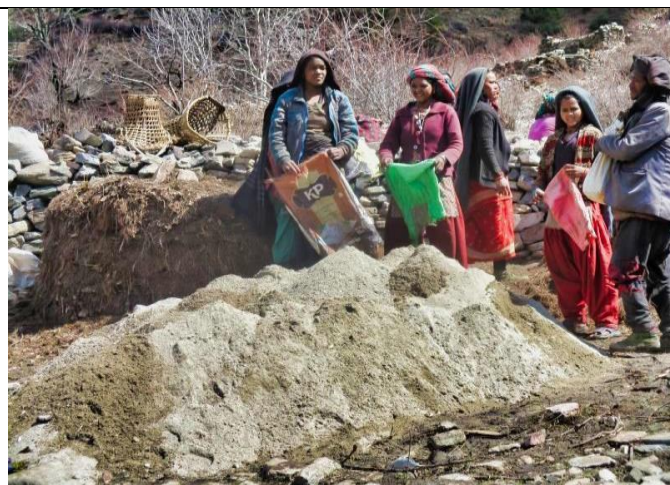
**Pic. 4:** The sand required for all cement work is collected from the local river bed. This is sieved so that the correct sand grain is achieved

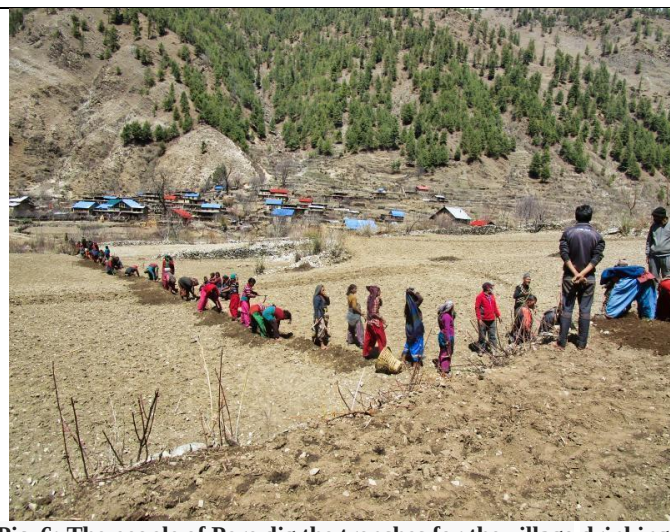
**Pic. 6:** The people of Pere dig the trenches for the village drinking water system. One person digs every ~ 2 meters so that the entire water pipeline can be laid in the shortest possible time. Every family sends at least one person every day to work on the new village drinking water system

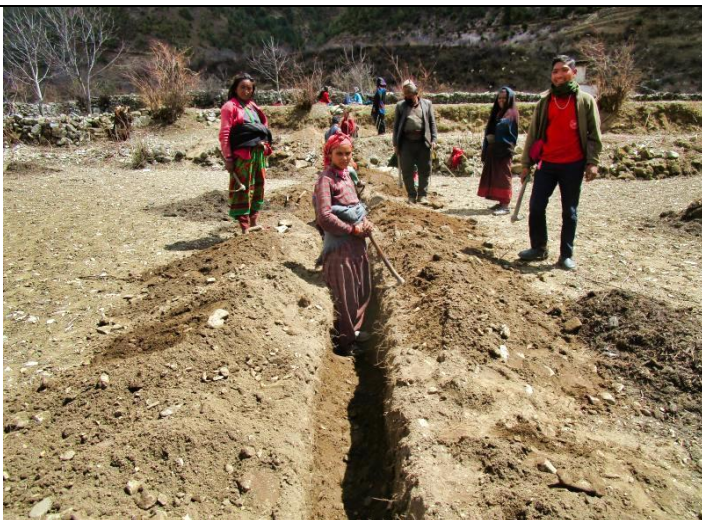
**Pic. 7:** The trenches are 50-60cm deep and 50 cm wide so that the water in the pipes never freezes, even in winter. People from the PIC team trained by RIDS-Nepal, check compliance with the prescribed depth

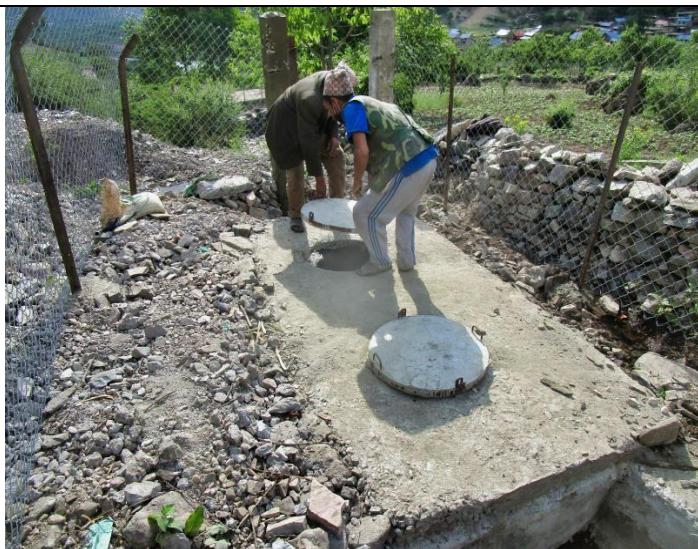
**Pic. 17: The water source intake and sedimentation tanks with cement walls and cover to protect the source water**

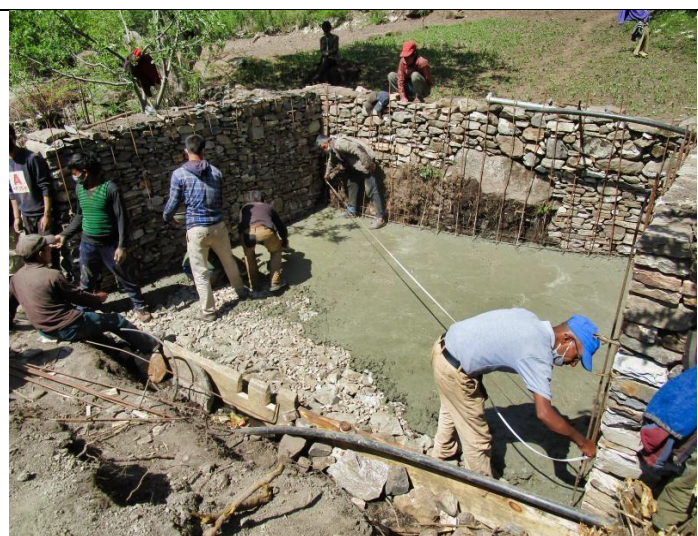
**Pic. 20:** Measuring and cementing the floor of the 25m<sup>3</sup> storage water tank under guidance of the RIDS-Nepal staff Bam Bahadur, to assure the storage tank size is sufficient

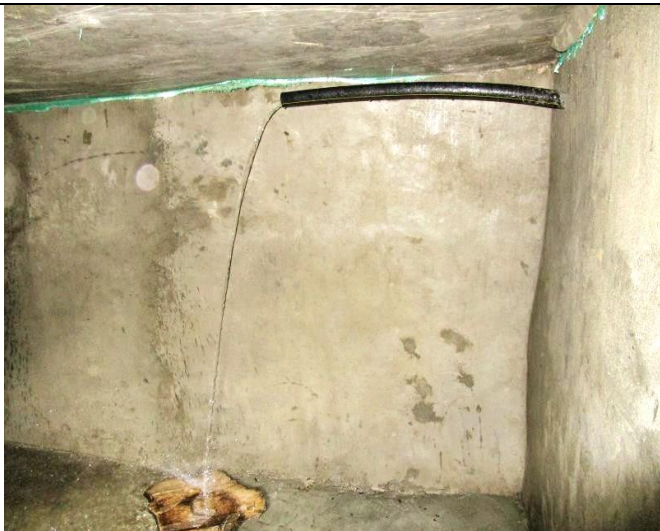
**Pic. 23:** In order to access the 25m<sup>3</sup> storage water tank a man-hole is integrated into the cemented cover lid. In this way the storage water tank is safe from contaminations and can be checked and cleaned periodically and easily

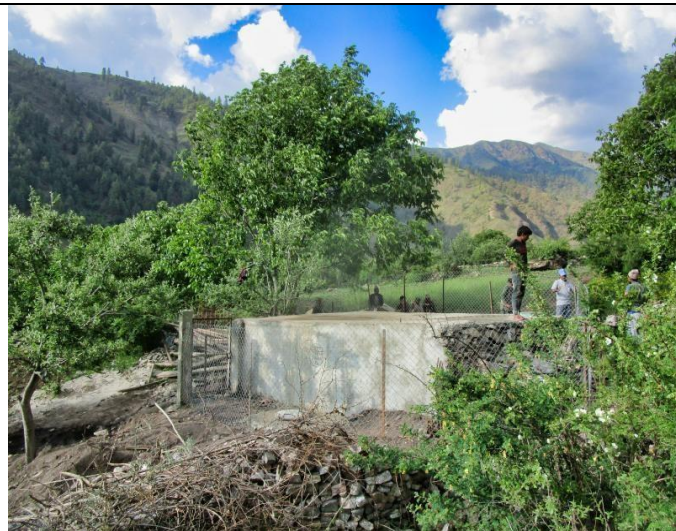
**Pic. 24:** The 25m<sup>3</sup> water storage tank is fully cemented on the inside, to prevent any leakage and to keep the water safe. The water flows from the spring through the ~1200 m long, underground buried, HDPE pipe into the tank

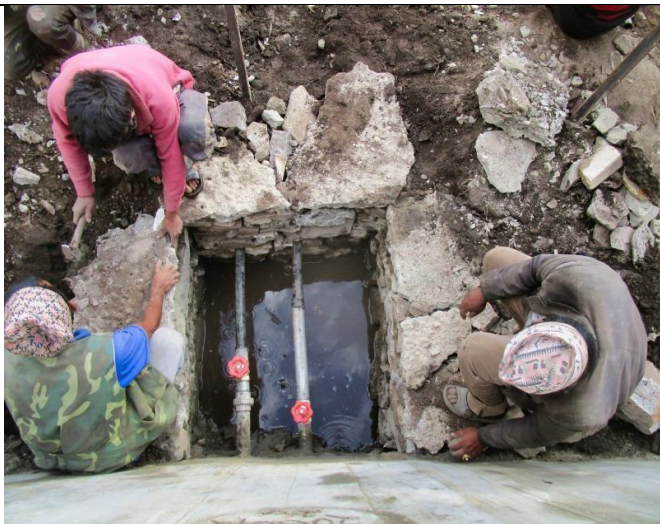
**Pic. 26:** The 25m<sup>3</sup> water storage tank is connected with four metal pipes, three of which are underground and one inside the tank respectively. From the water source, outlet to the 15-water tap stands in the village, overflow and for aeration. Here we see the outlet & overflow pipes, accessible for O&M

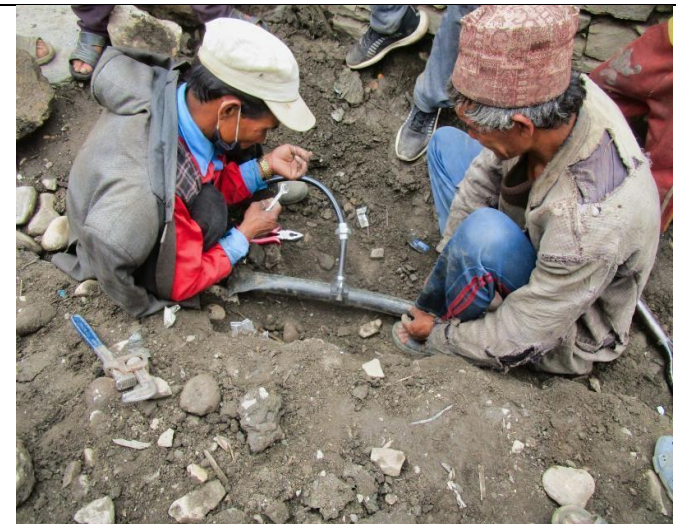
**Pic. 27:** The larger HDPE (High-Density-Polyethylene) pipe is the major pipe which is connected to the outflow metal pipe from the storage tank (Pic. 26) and going to all the 15 different water tap stands in the village. Here, a smaller HDPE pipe is connected to the bring water to one of the tapstands

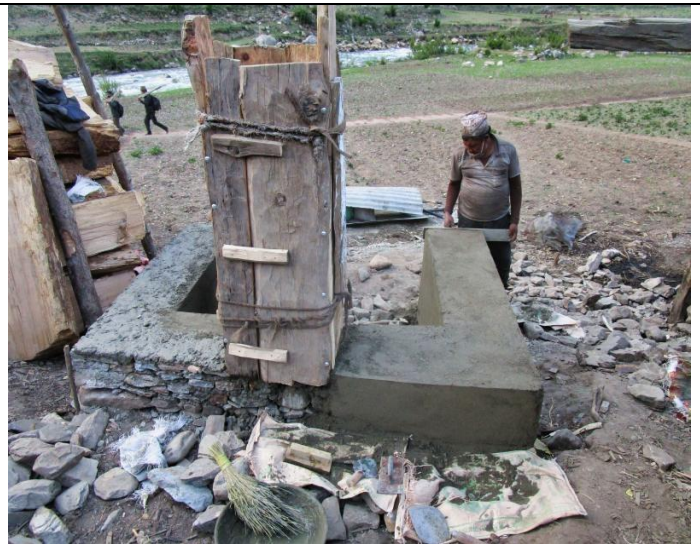
**Pic. 30:** RIDS-Nepal staff Bam Bahadur teaches the local people how to set up a tap stand foundation, by lining out the main stone walls and measuring that all is at correct angles

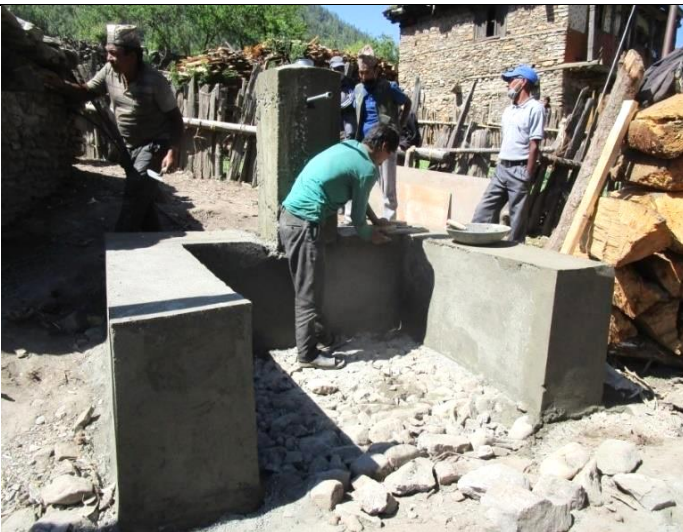
**Pic. 32:** One of the Pere village tap stands gets the finish top layer of cement which is a 1:1 cement-sand mixture to create a smooth and water proof surface, providing the tap stands' walls with a long-lasting protective surface

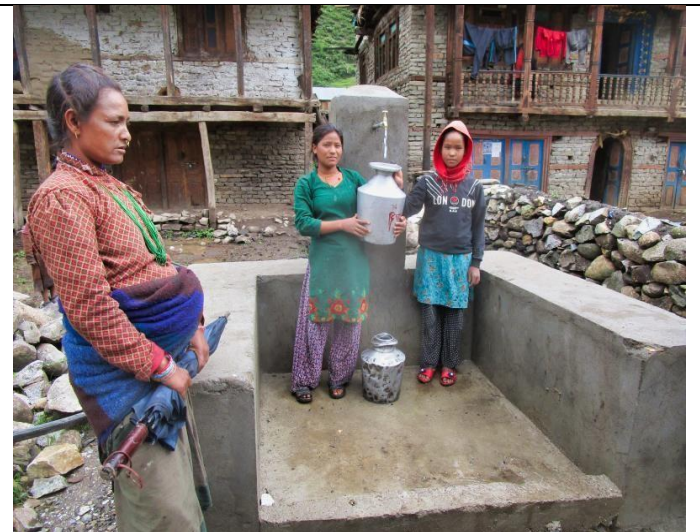
**Pic. 33:** A finished tap stand in Pere village providing now 2 hours in the morning and 3 hours in the evening water for the Pere families. Each family has to walk now only 1-3 minutes to fetch sufficient, clean, drinking water

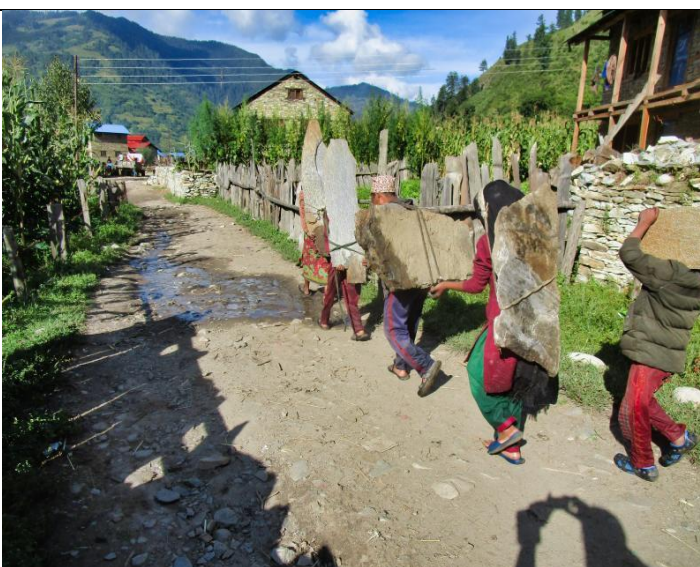
**Pic. 44:** Slate plates are prepared in a nearby quarry and carried home to cover the PL septic tank

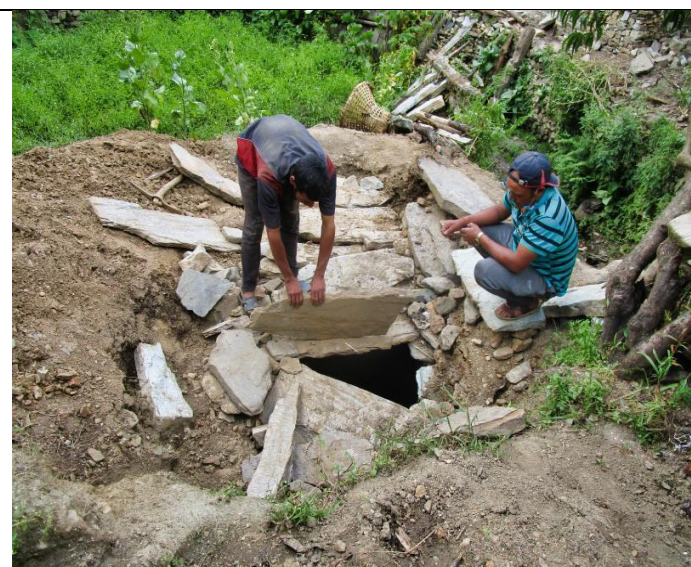
**Pic. 45:** With the prepared slate plates the built PL septic tank is covered. Additionally, mud is laid on top of the slate plates

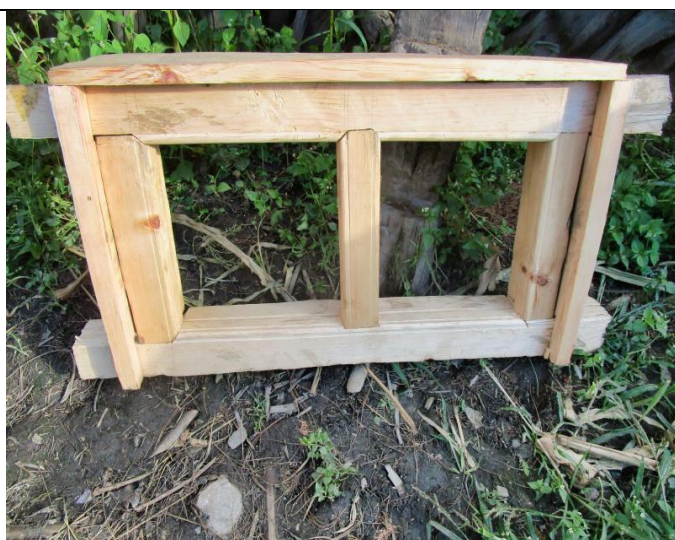
**Pic. 46:** A window for the Pit Latrine is produced to enable some air ventilation. The skill training for the families with no carpentry skills is provide by RIDS-Nepal

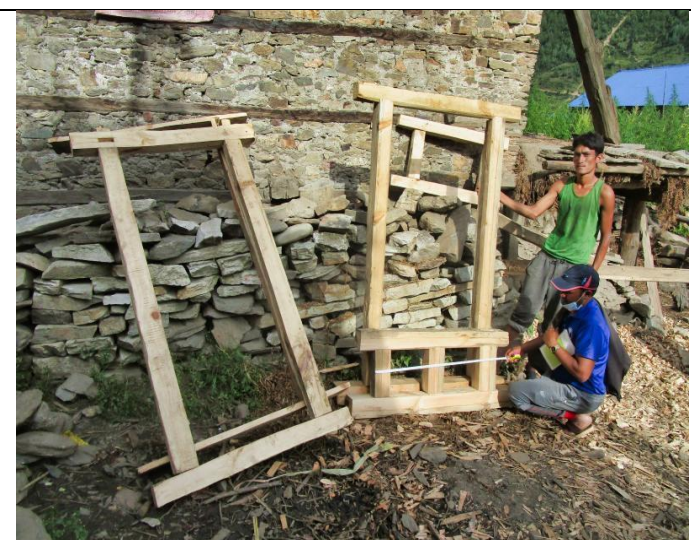
**Pic. 47:** Main Pit Latrine door frame, door and a small window to ventilate the Pit Latrine are made by each family under guidance and supervision of RIDS-Nepal's staff

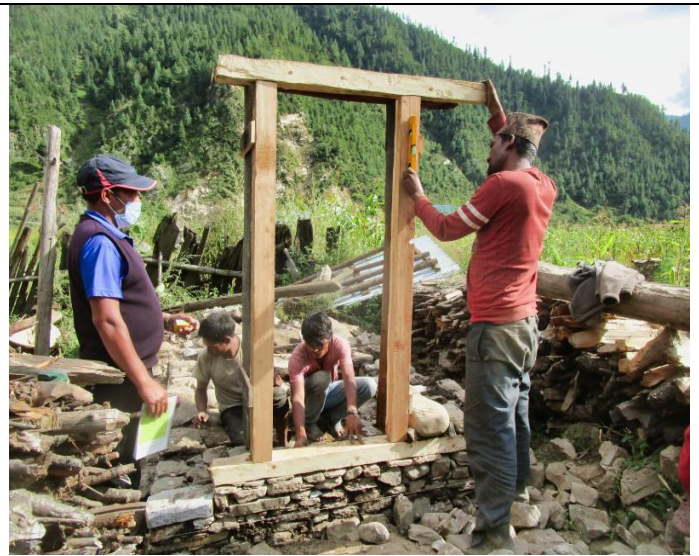
**Pic. 48:** RIDS-Nepal staff assure that the PL door foundation is leveled before building the stone wall around it

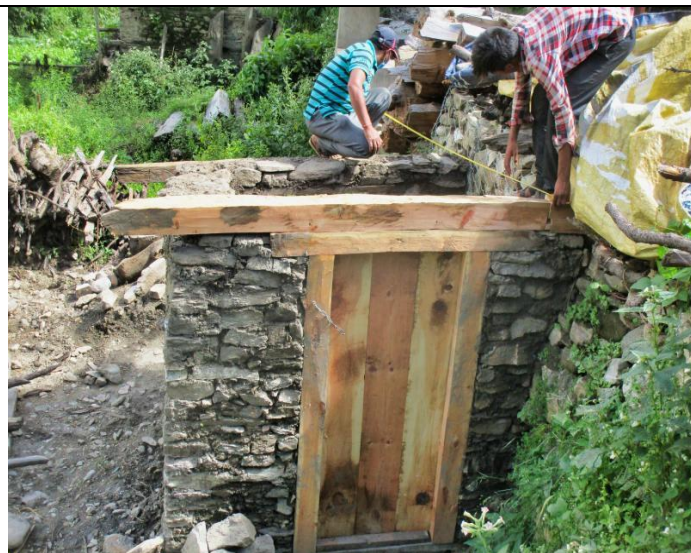
**Pic. 55:** The length of the PL roof is measured to assure that the three galvanized tin roofs fit as designed on the PL roof

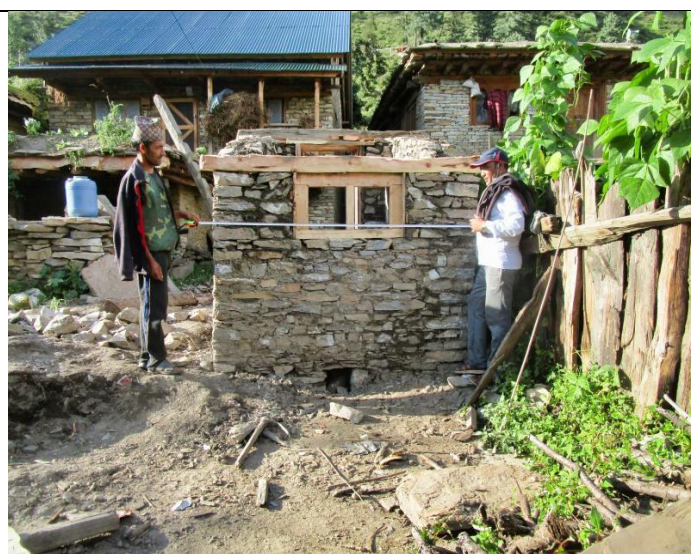
**Pic. 57:** The width of the PL is measured to assure that the insides dimensions are kept as per designed RIDS PL standard

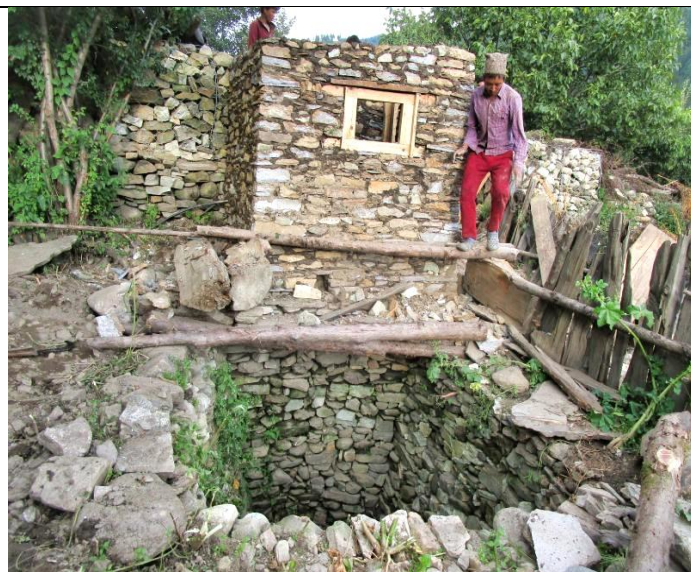
**Pic. 59:** A family PL stone house is built with the ready to cover septic tank to collect the liquid and solid effluents

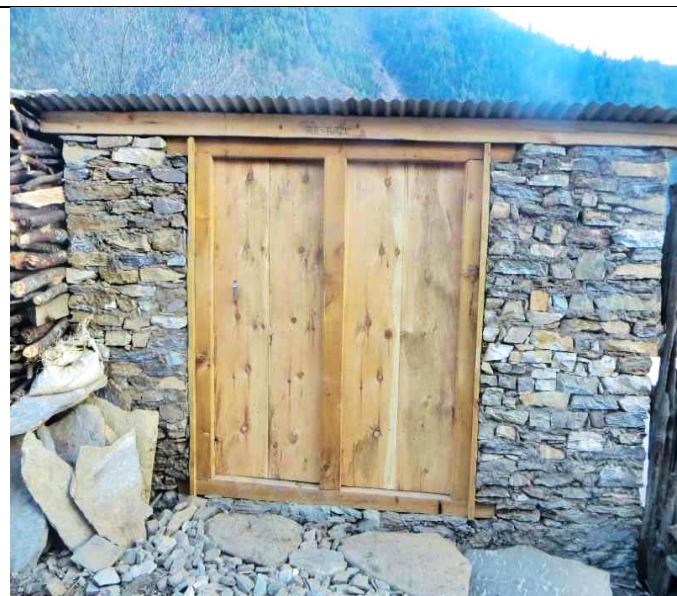
**Pic. 63: A fully completed pit latrine and bathing house structure constructed in Pere**

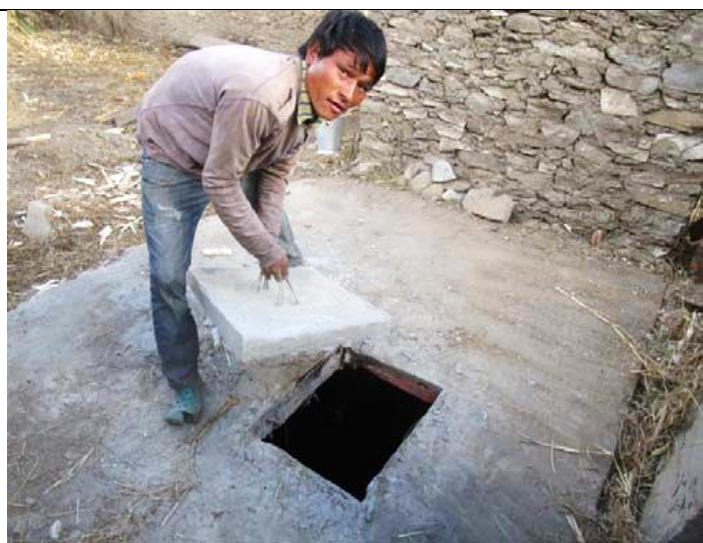
**Pic. 64: A newly constructed septic tank for the family pit latrine which can be used for approximately 8 years before it needs to be emptied for re-use**

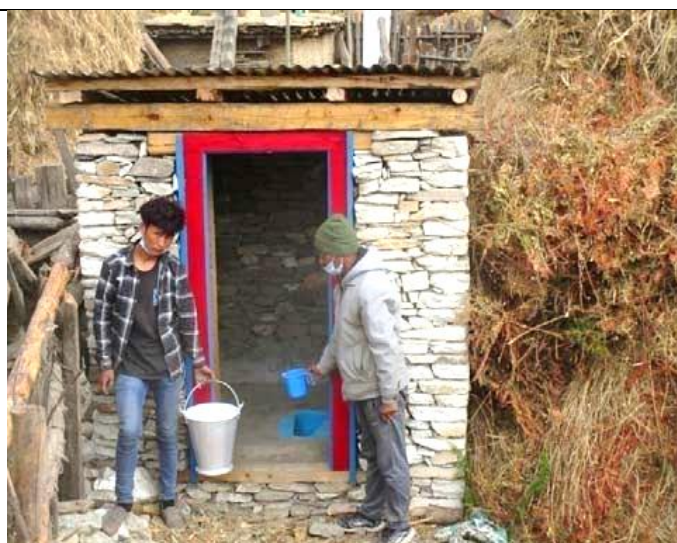
**Pic. 65: A newly built and fully completed pit latrine already in use by the family who owns it. RIDS staff Bam Bahadur inspects the pit latrine if it is maintained correctly and hygienically**

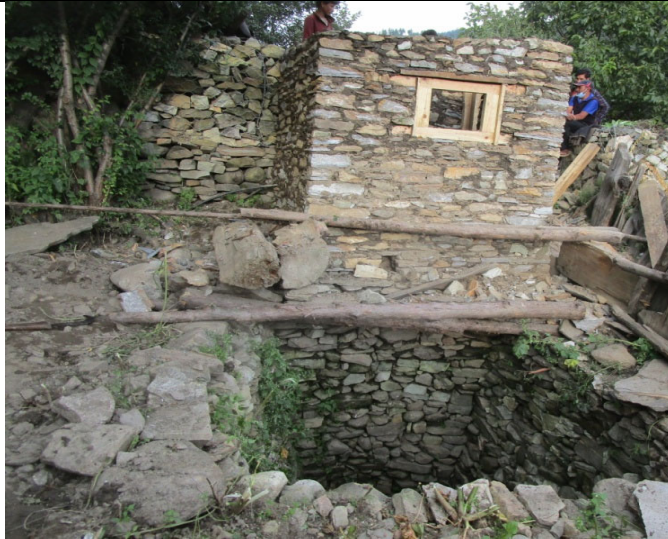
**PIC.88.** A family PL (Pit Latrine) stone house is being built with the ready to cover septic tank to collect the liquid and solid effluents.

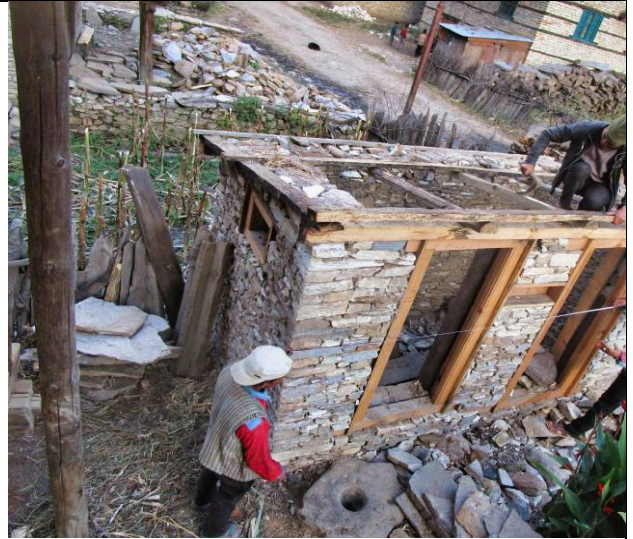
**PIC.89.** 2 PLs are built together due to lack of land. Length of the PL roof is measured to assure that the three galvanized tin roofs fit as designed on the PL roof.

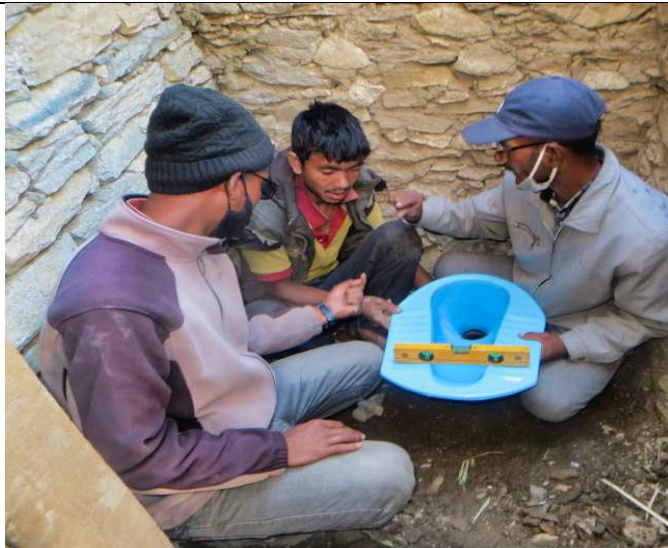
**PIC.92.** Two Pere project staff teach how to fix the toilet pan in new constructed PL.

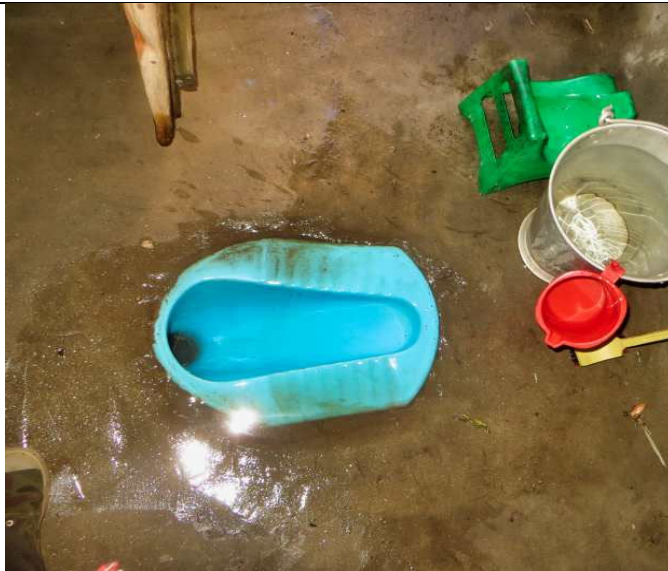
**PIC.94.** Inside view of a newly built Pit Latrine in Pere village.

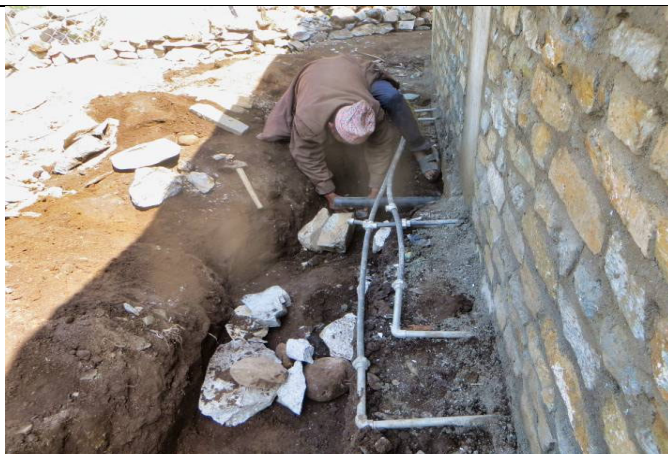
**PIC.112.** The skilled labors are installing pipelines for both cold and hot water systems in Pere.

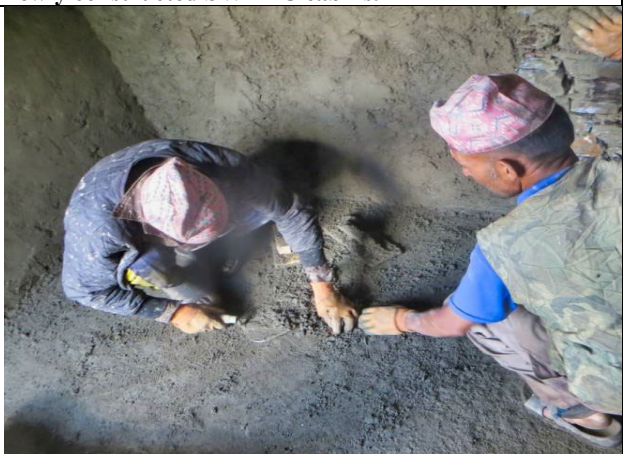
**PIC.113.** The skilled labors are plastering the walls and floors of SHWBC in Pere.

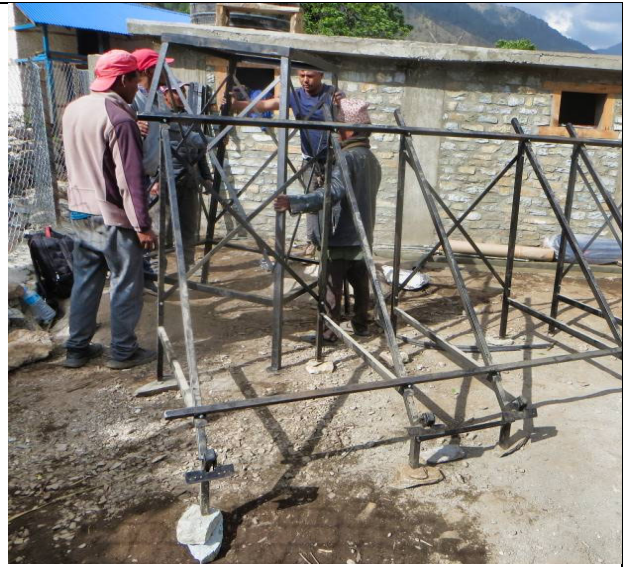
**PIC.115. The skilled labors have set up metal frame to installed SHWBC system.**

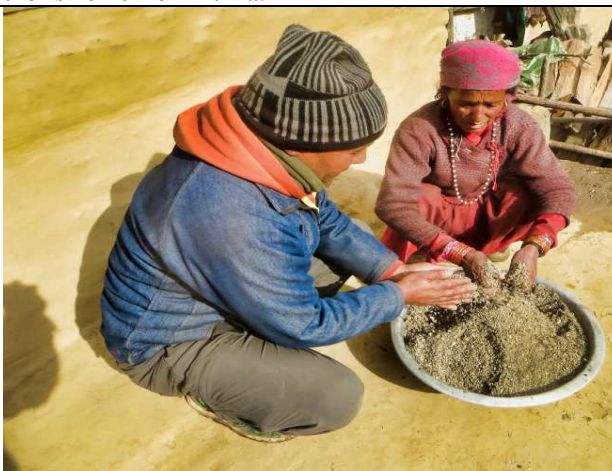
**PIC.125. Mansingh (RIDS staff) teaches how to prepare/wash the sand for the SSWF.**

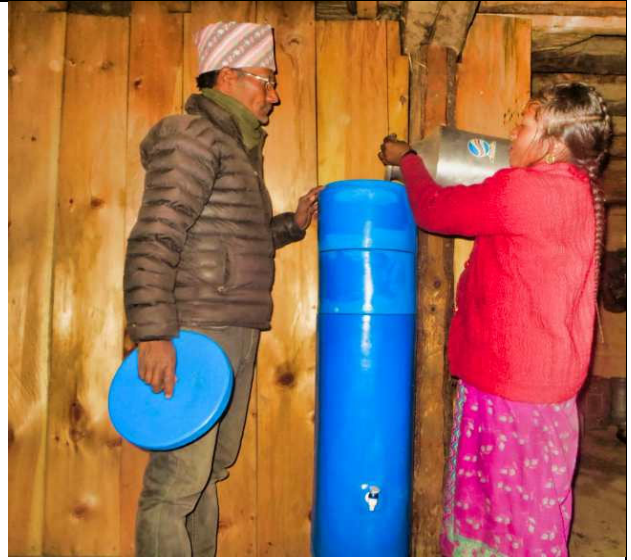
**PIC.133. Bam Bahadur teaches a Pere family how to install and use their SSWF in the home correctly by filling it with water regularly twice a day.**

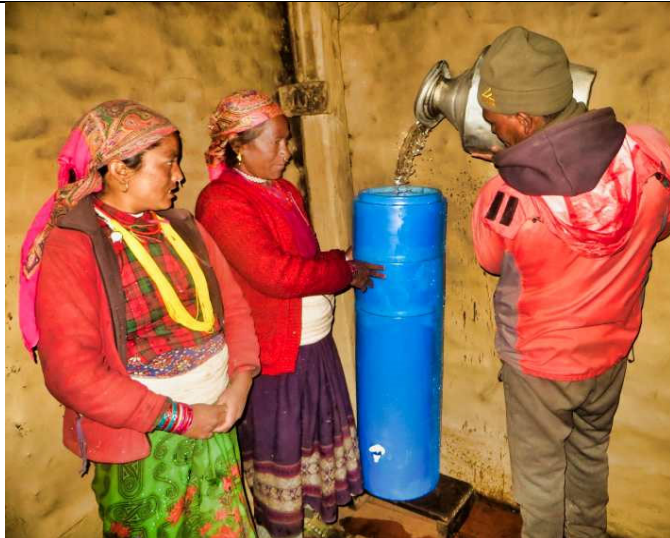
**PIC.134. Karna is helping and teaching two Pere women how to fill water regularly in the SSWF to keep the sand constant wet for best and clean drinking water quality.**

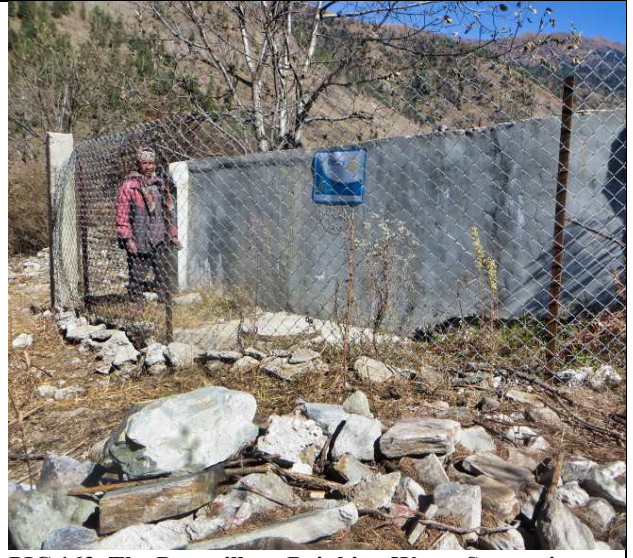
**PIC.162. Ongoing inspection and cleaning of the 25m3 seized DWS (Drinking water system) water storage tank by Pere project staff and local trained maintenance people.**

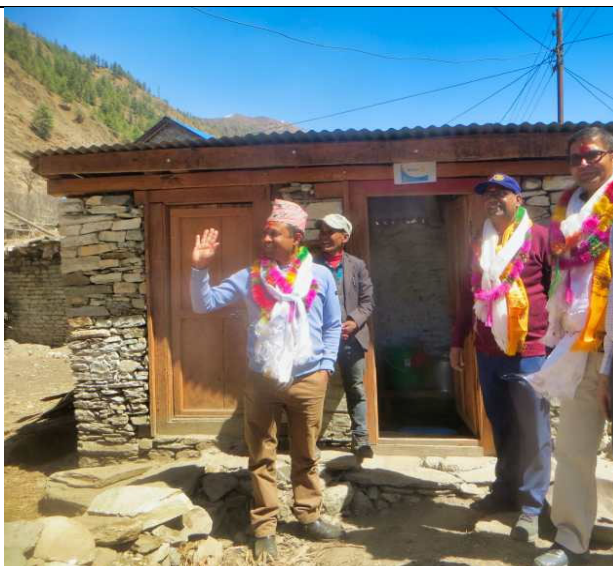
**PIC.168. The project evaluation team is checking newly constructed DWS tap stands.**
